# Storm damage and coastal protection

## A case study of Chesil Cove

Last winter's storms repeatedly battered the Dorset coast. In this photo-essay Alan Holiday examines how the coastal defences at Chesil held up

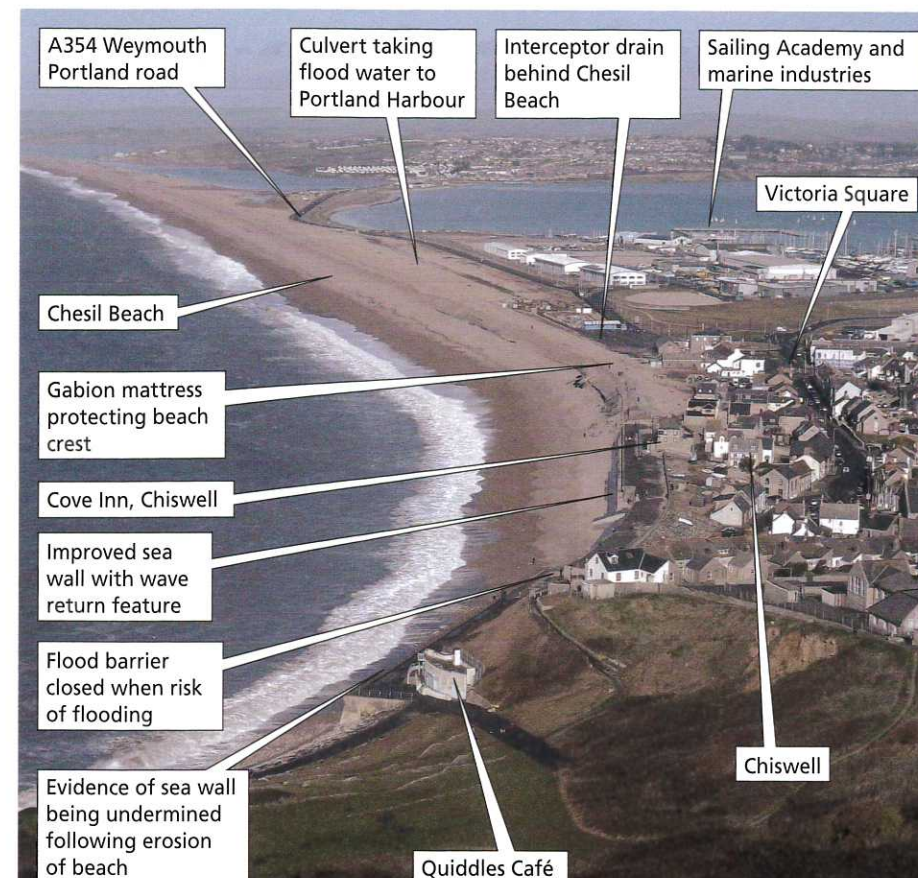
Photograph 1 Annotated photo of southern end of Chesil Beach showing the features mentioned in the text

The coastal protection scheme built in the 1980s (Photograph 1) included:

- protecting the crest of the southeast end of Chesil Beach with gabions and a gabion mattress (steel cages filled with stone)
- improving the sea wall along Chesil Cove
- providing a storm drain to remove flood water that overtopped the beach or percolated through it

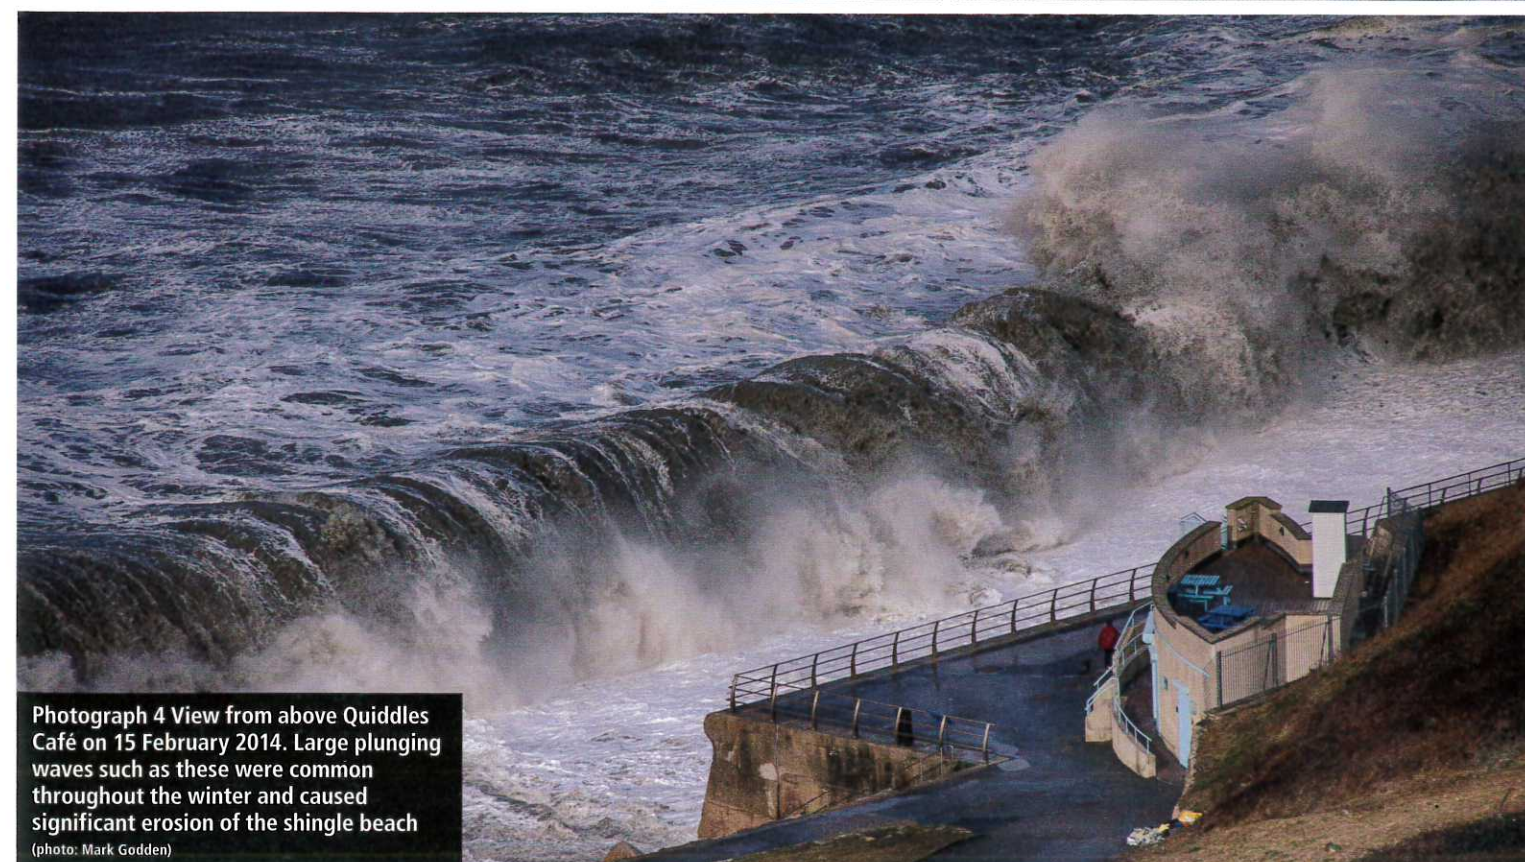
Photograph 4 View from above Quiddles Café on 15 February 2014. Large plunging waves such as these were common throughout the winter and caused significant erosion of the shingle beach (photo: Mark Godden)

positioned unusually far south over southern England (see Further research and this issue's Centre piece on pp. 20–21). It produced a series of deep depressions which brought strong winds and heavy rain to the Dorset coast. The high winds resulted in a prolonged period of destructive plunging wave activity (Photograph 4 and the YouTube link in Further research) which had significant impacts on the shingle beach.

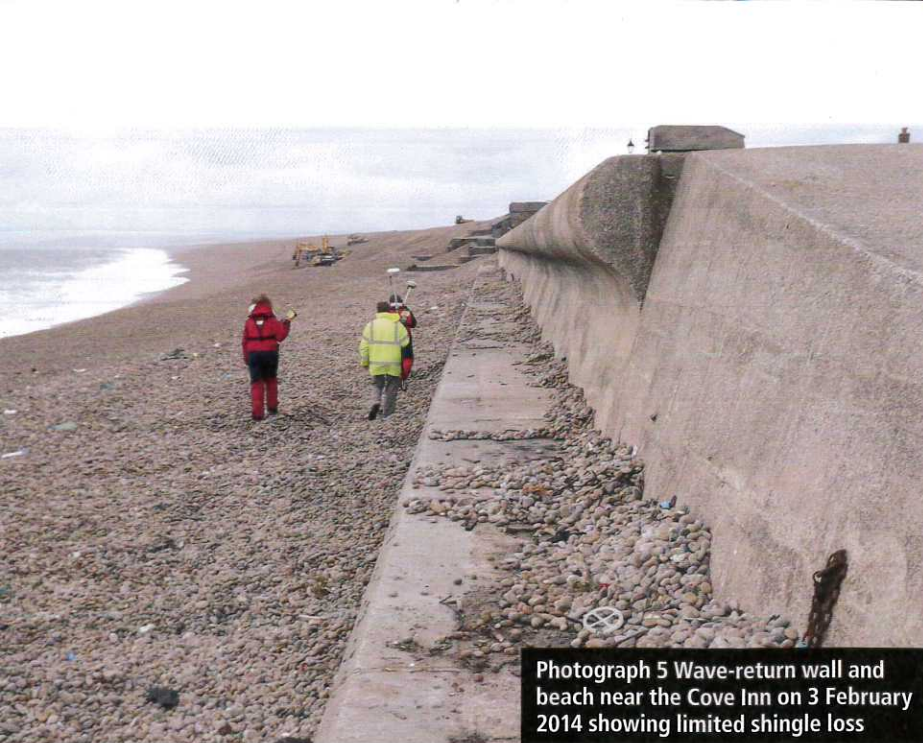
Photograph 5 Wave-return wall and beach near the Cove Inn on 3 February 2014 showing limited shingle loss

The constant pounding of storm waves, especially on 5 and 14/15 February 2014, moved shingle from Chesil Beach offshore, reducing the ability of the beach to absorb the energy of the waves and act as a natural means of coastal protection (Photographs 5–8). Erosion was so severe that the shingle was completely removed in Chesil Cove and the Kimmeridge clay bedrock was exposed. This is very unusual and last occurred in 1989.

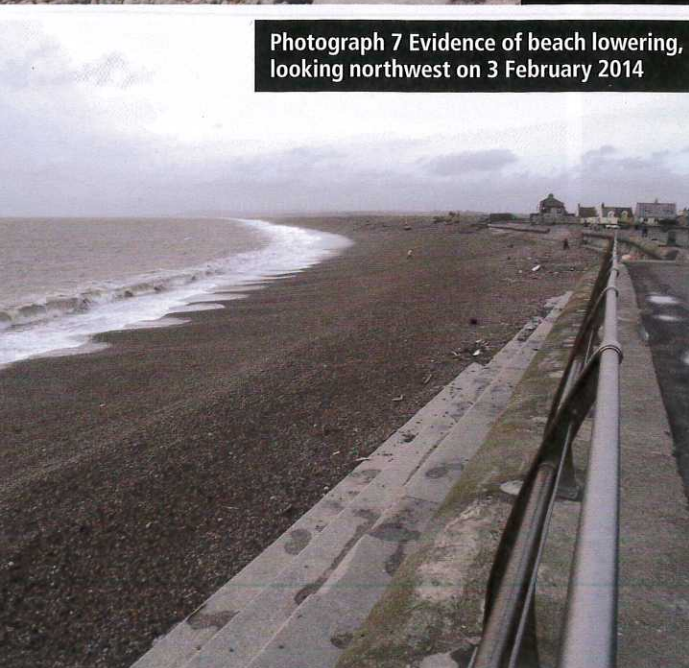
Photograph 7 Evidence of beach lowering, looking northwest on 3 February 2014

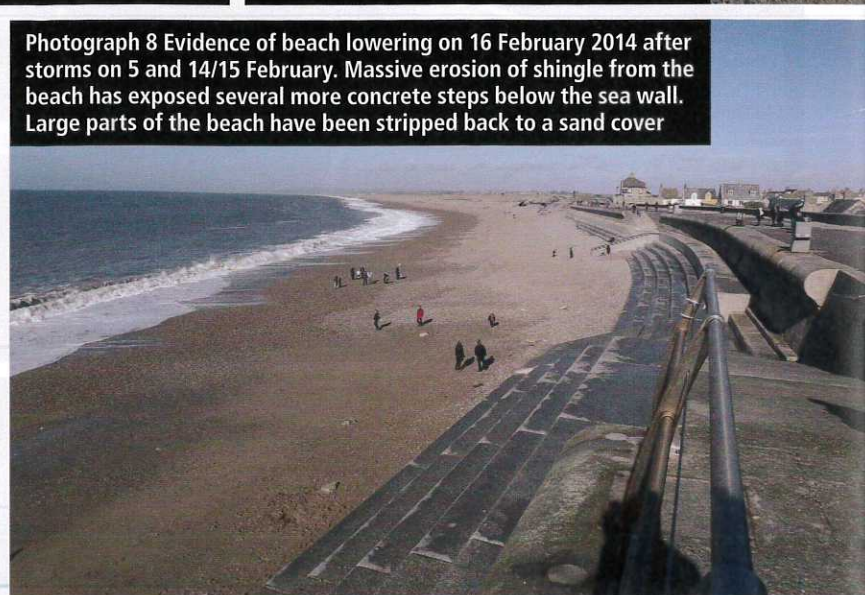
Photograph 8 Evidence of beach lowering on 16 February 2014 after storms on 5 and 14/15 February. Massive erosion of shingle from the beach has exposed several more concrete steps below the sea wall. Large parts of the beach have been stripped back to a sand cover

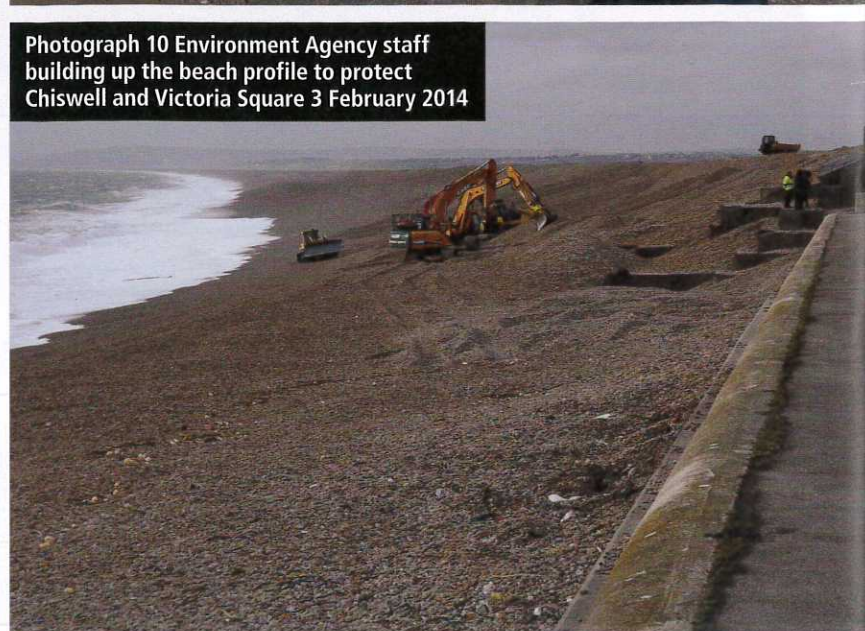
Photograph 10 Environment Agency staff building up the beach profile to protect Chiswell and Victoria Square 3 February 2014

■ Over a period of around 6 weeks the beach was lowered by 3.5 metres as depression after depression affected the coast. During brief respites storm ridges built up and this material was used by the Environment Agency to re-grade the beach profile and to provide some protection (Photograph 10).

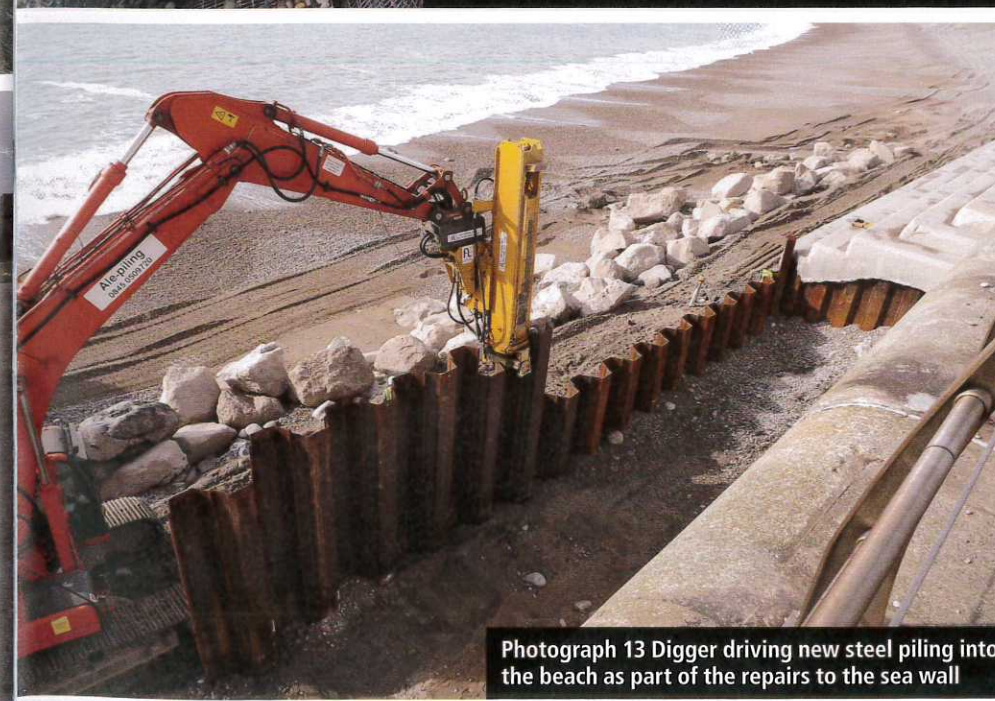
Photograph 13 Digger driving new steel piling into the beach as part of the repairs to the sea wall

Following the February storms the sea wall was strengthened with new sheet piling to protect the part which had been undermined (Photograph 13). While this was taking place some rock armour (Portland limestone) was placed on the beach to provide extra protection and absorb some of the wave energy.
